# Flightdeck Party Line Issues: An Aviation Safety Reporting System Analysis

June 1995

DOT/FAA/CT-TN95/12

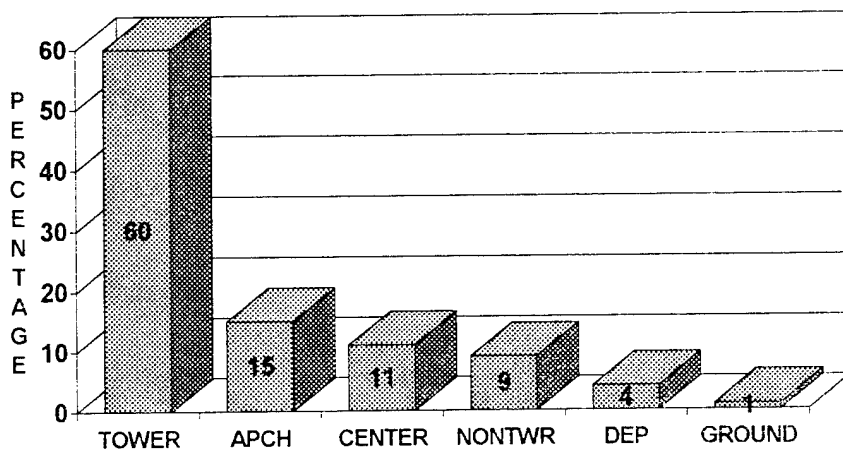
FIGURE 1. CONTROLLING AGENCY

Figure 1 shows the distribution of controlling agencies involved in the reports. Sixty percent of the incidents reported party line transmissions over the tower frequency. The tower controller's (or local controller's) responsibility is for operations on the active runway for both departing and arriving traffic.

Only 11 percent of the reports involved the center frequency. The majority of these reports involved altitude instructions that were incorrectly taken because of missed call signs. The others involved either position reports, holding instructions, or traffic information. When considering all but the center frequency, the percentage of PLI elements conveyed at or near the airport increases to 89 percent. This supports the research literature of Brown, 1991 and Midkiff, et al., 1993, in that the party line is used more extensively near the airport.

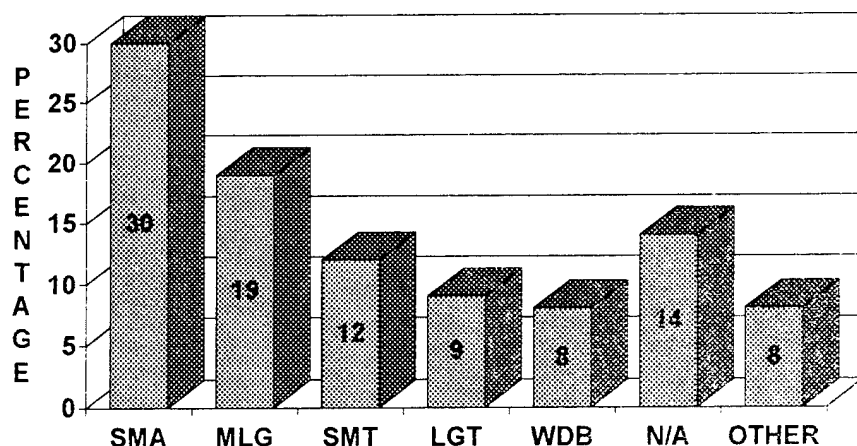
FIGURE 2. TYPE OF AIRCRAFT

Figure 2 portrays, in order of occurrence, the various types of aircraft involved in the incidents. Note: The aircraft of both the listener and the receiver of the party line information were counted in the data. The majority of aircraft involved in the incidents were Small Aircraft (SMA) (30 percent) flying under Visual Flight Rule (VFR) conditions.

The rest, in order of their occurrence: Medium Large Transport (MLG) (19 percent), Small Transport (SMT) (12 percent), Large Transport (LGT) (9 percent), Wide Body (WDB) (8 percent) and Other (8 percent). Fourteen percent of the aircraft were unable to be determined from the report.

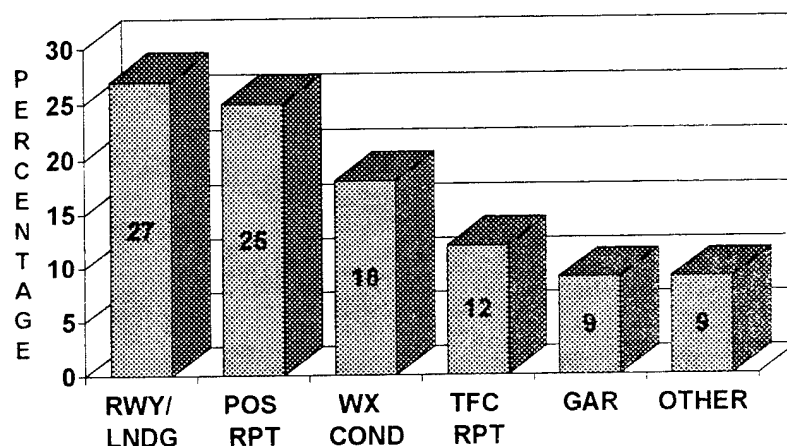
FIGURE 3. ADVISORY PLI ELEMENTS

Figure 3 depicts the distribution of the advisory PLI elements found in the reports. The breakdown is as follows: Runway/Landing Intentions (27 percent), Position Report (25 percent), Weather Information/Conditions (18 percent), Traffic Reports (12 percent), Go-around Intentions (9 percent) and Other (9 percent). Traffic reports were considered separate and distinct from position reports as they were information conveyed by air traffic control; position reports were conveyed by flight crews.

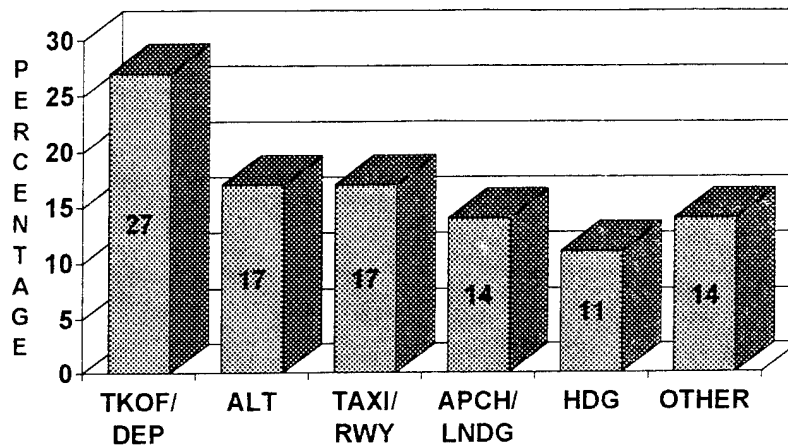
FIGURE 4. INSTRUCTIONAL PLI ELEMENTS

Figure 4 depicts the distribution of the instructional PLI elements. The breakdown is as follows: Takeoff/Departure Clearances (27 percent), Altitude Clearances (17 percent), Taxi/Runway Clearances (17 percent), Approach/Landing Clearances (14 percent), Heading/Vector Clearances (11 percent) and Other (14 percent). The other category contained less prevalent elements such as information regarding missed approaches, touch and go's, holdings, etc. Three of the top four categories involved operations at or near the airport surface; this again, portrays the prevalence of party line information in the terminal environment.

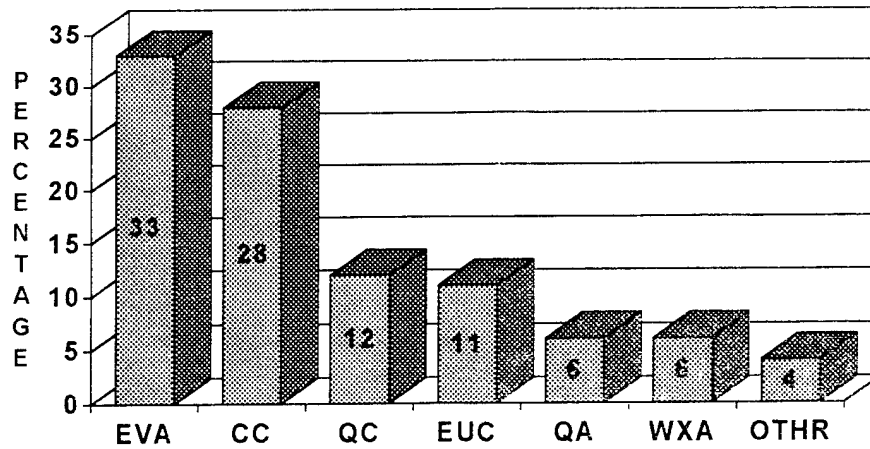
FIGURE 5. LISTENER ACTIONS

Figure 5 provides a distribution of the listener actions that were based on the party line. The following actions were identified: Evasive Action (EVA) (33 percent), Continued Clearance (CC) (28 percent), Query Controller (QC) (12 percent), Executed Unauthorized Clearance (EUC) (11 percent), Query Aircraft (QA) (6 percent), Weather Awareness/Avoidance (WXA) (6 percent) and Other (OTHR) (4 percent). Actions that were not as

prevalent (e.g., request clearance, programming of the FMS) were combined into the Other category.

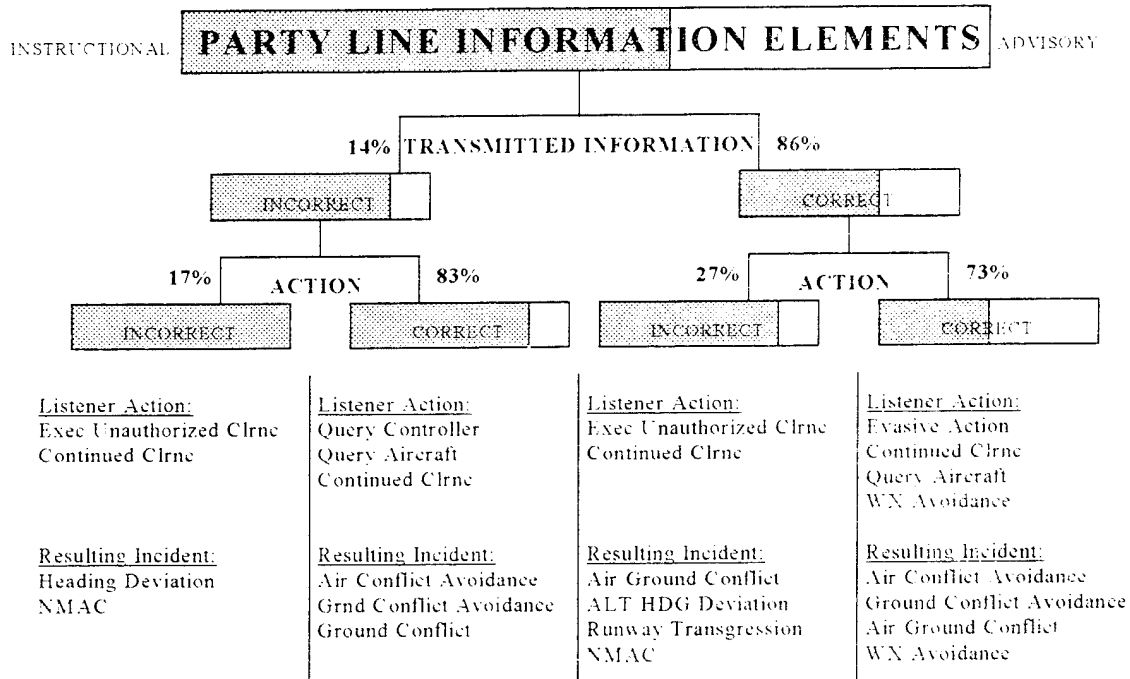
FIGURE 6. ERROR ANALYSIS TREE

The discussion that follows expands on the previous sections by showing how all the information is related to one another. This was accomplished through an error analysis; taking each component of the party line, from the transmission of the information to the actions performed by the flight crews and determining where the problems lie. The results of this analysis are depicted in the error analysis tree shown in figure 6.

There are two different kinds of errors that are directly attributed to the information conveyed over the party line. They are as follows: (1) errors attributed to incorrect transmission (first level branch); and (2) errors resulting from incorrect actions by the flight crews (second level branch).
